September 26, 2012

**RE: Initial Reconnaissance Site Visit and Implications of Division of Safety of Dams Jurisdiction at Lake Van Norden, Soda Springs, Placer and Nevada Counties, California**

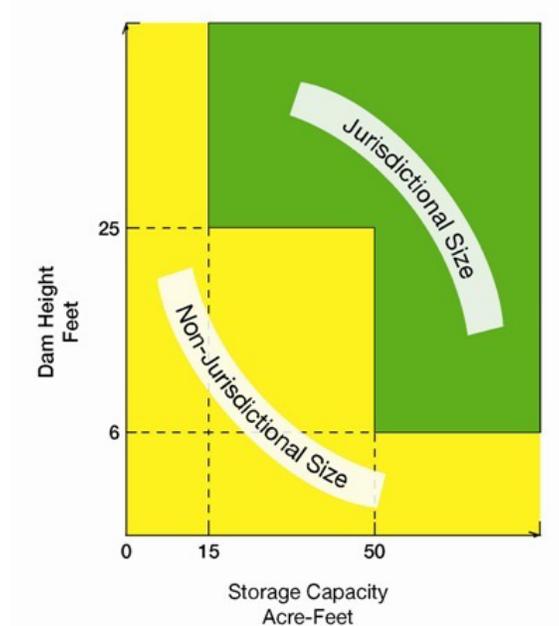
Figure 1. Provisions of Division 3 of the California Water Code affecting jurisdiction over dams and reservoirs. (Source: California Department of Water Resources, Division of Safety of Dams, downloaded from <http://www.water.ca.gov/damsafety/jurischart/index.cfm>)

Figure 1 outlines the dam and reservoir parameters that dictate whether a dam is under the jurisdiction of the California DSOD. You have provided a bathymetric map and point depth data for the lake under current conditions, as developed by Chuck Kull (unpublished). The elevation of the spillway, as measured from the toe of slope on the downstream side, is greater than 6 feet and less than 25 feet (C. Kull, pers. comm.). While significant habitat and water quality benefits, and perhaps structural benefits to the dam, could be achieved by modifying the existing plunge pool and dirt parking lot at the downstream toe of the spillway slope, we also understand that these modifications would not warrant removing the dam from DSOD jurisdiction (C. Kull pers. comm.), even if the modifications resulted in a dam height of less than 6 feet. Therefore, the only other method of removing the dam from jurisdiction would be to lower the water level to achieve a storage capacity of less than 50 acre-feet.
